# **Access Audit of LBSNAA**

**Mussoorie**

carried out by **Access Ability**

**in 2008**

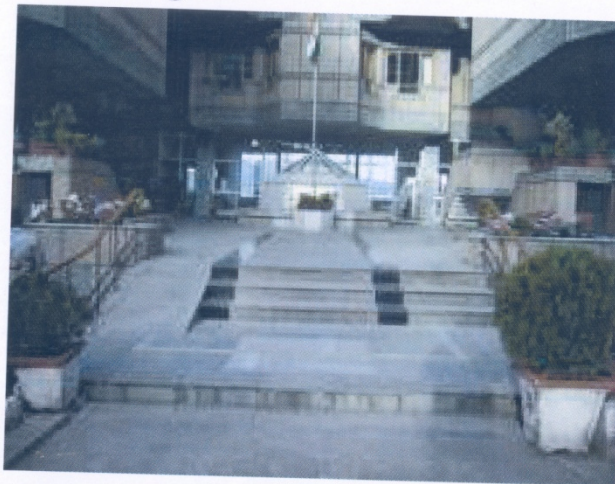
## Existing:

- There are 1+3 steps at the entrance that are accompanied with handrails.
- The 3 steps are bypassed by a steep ramp that:
  - has a gradient of 1:4,
  - provides a clear width of only 900mm
  - does not stand out from the rest of the flooring
  - has slippery flooring

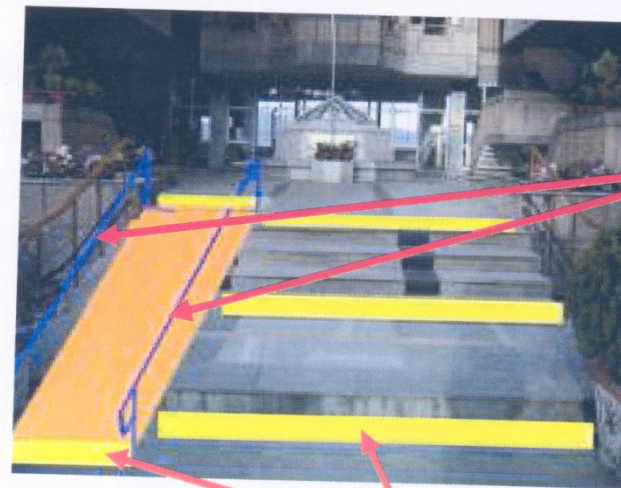
## Proposed:

Handrails

Tactile Warning Blocks

1. Designate an accessible car parking bay next to the Dhruvshila complex for use of disabled driver/passengers. Design guidance for accessible car parking bay are given in annexure.
2. Construct a 1200mm wide ramp\* to bypass the first step (160mm high).
3. Refurbish the existing ramp\* (over the 3 steps) as illustrated in the adjoining picture, so that it :
  - has a maximum gradient of 1:12;
  - has a minimum clear width of 1200mm;
  - has tactile warning blocks at the beginning and the end
  - has handrails on both the sides
  - the flooring is non-slip and contrasts in colour from rest of the flooring.
4. Install tactile warning blocks at the beginning and end of the steps at the entrance.

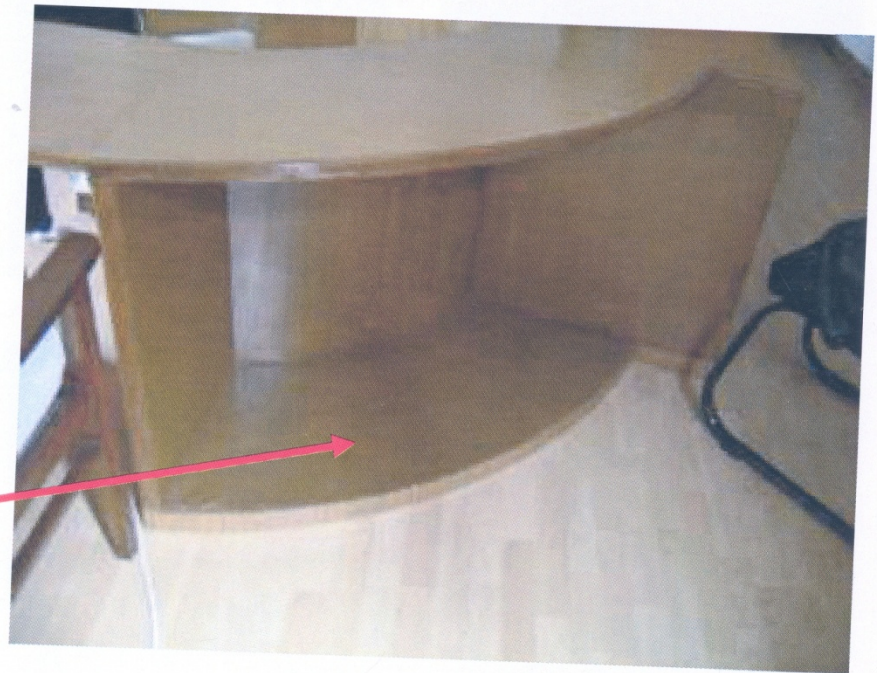
- The table does not stand out against the wooden flooring and therefore, can be a hazard for persons with vision impairments. It is recommended that the colour of table and chairs should contrast from the flooring.
- The table has a 60mm foot rest that may impede wheelchair proximity to the table for some wheelchair users. This should be removed from at least one seating space.

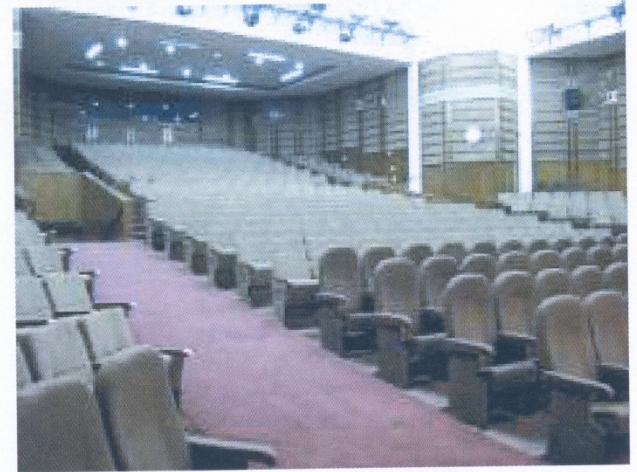
## Circulation Aisle:

- The internal steps in the auditorium are covered with the same carpet as the rest of the flooring and are therefore difficult to be distinguished from the flooring.
- Access to the stage (height: 920mm) is through a set of 6 steps. There is not enough space available to retrofit a ramp to bypass the existing steps.
- Circulation aisles and steps (at the rear half) are covered with the same carpet as the rest of the floor, and are therefore difficult to be distinguished by persons with vision impairments.
- The steps at the rear entrance do not have any handrails.
- The auditorium does not have any facilities to include persons with hearing impairments.
- There are no wheelchair seating spaces in the auditorium

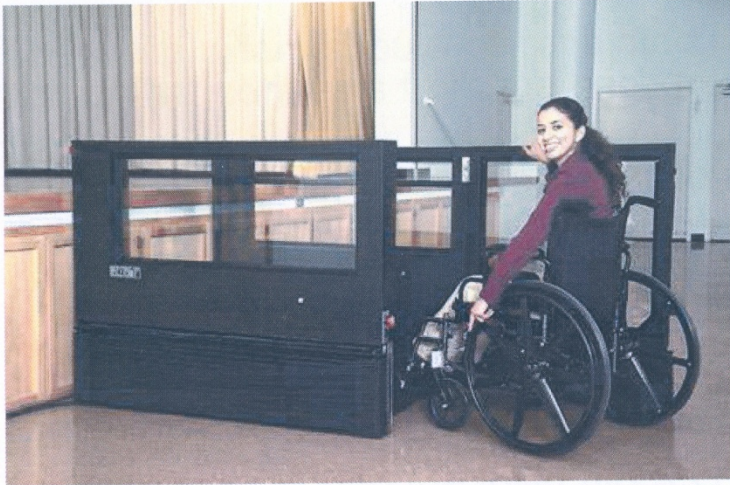
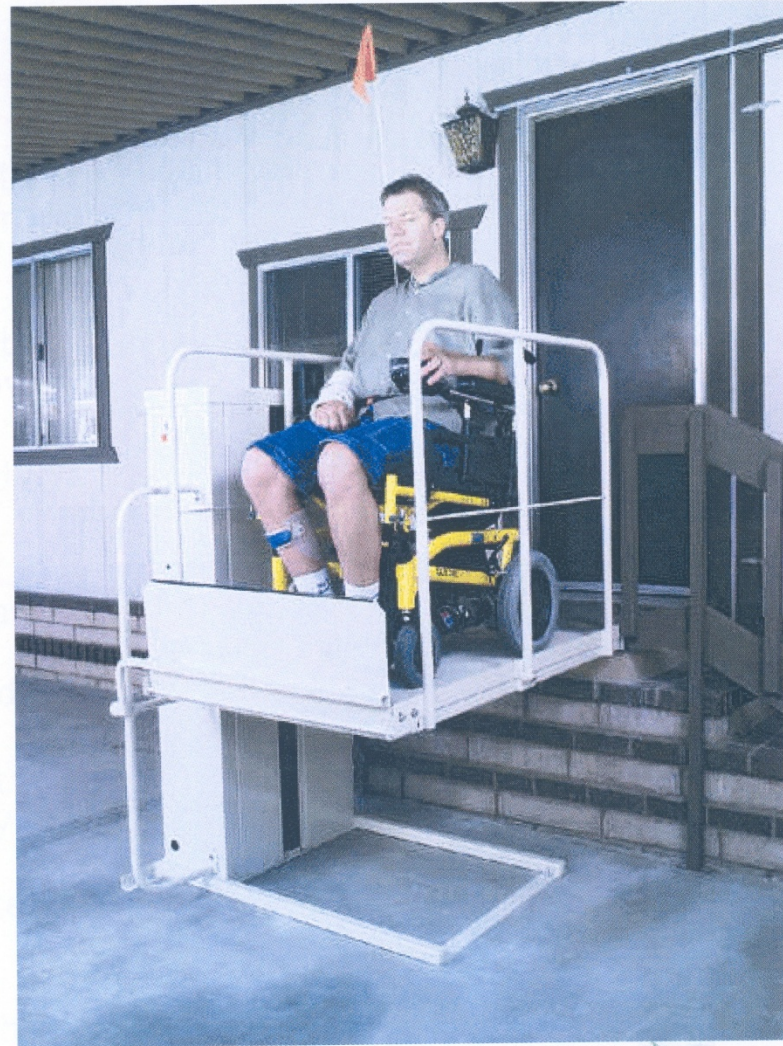
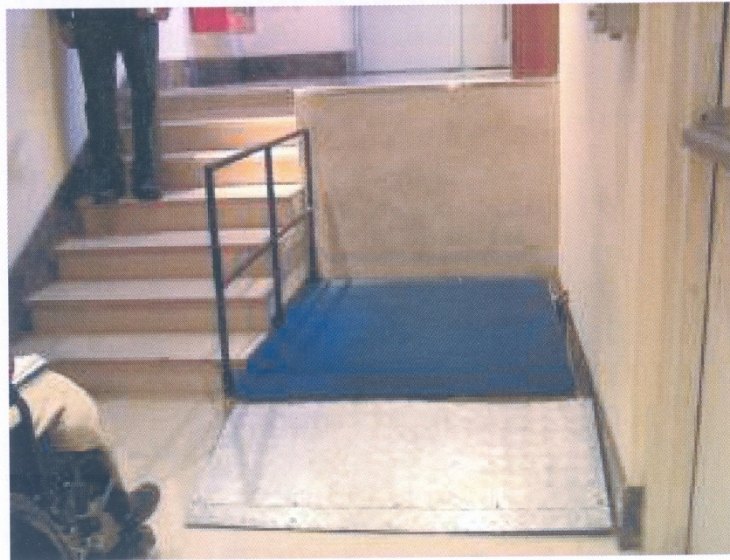
# Examples of Wheelchair Platform Lift

- Sufficient space is not available to replace the five steps leading to the stage with a ramp. Therefore, it is recommended to replace the stairs on one side with a Wheelchair Platform Lift (see adjoining pictures on the right hand side)
